McWater's Park Permaculture Gardeners

Permaculture Design Workshop
and Charrette

Site Assessment

**Edible Forest Garden
 McWaters Park
 North Bennington, Vermont**

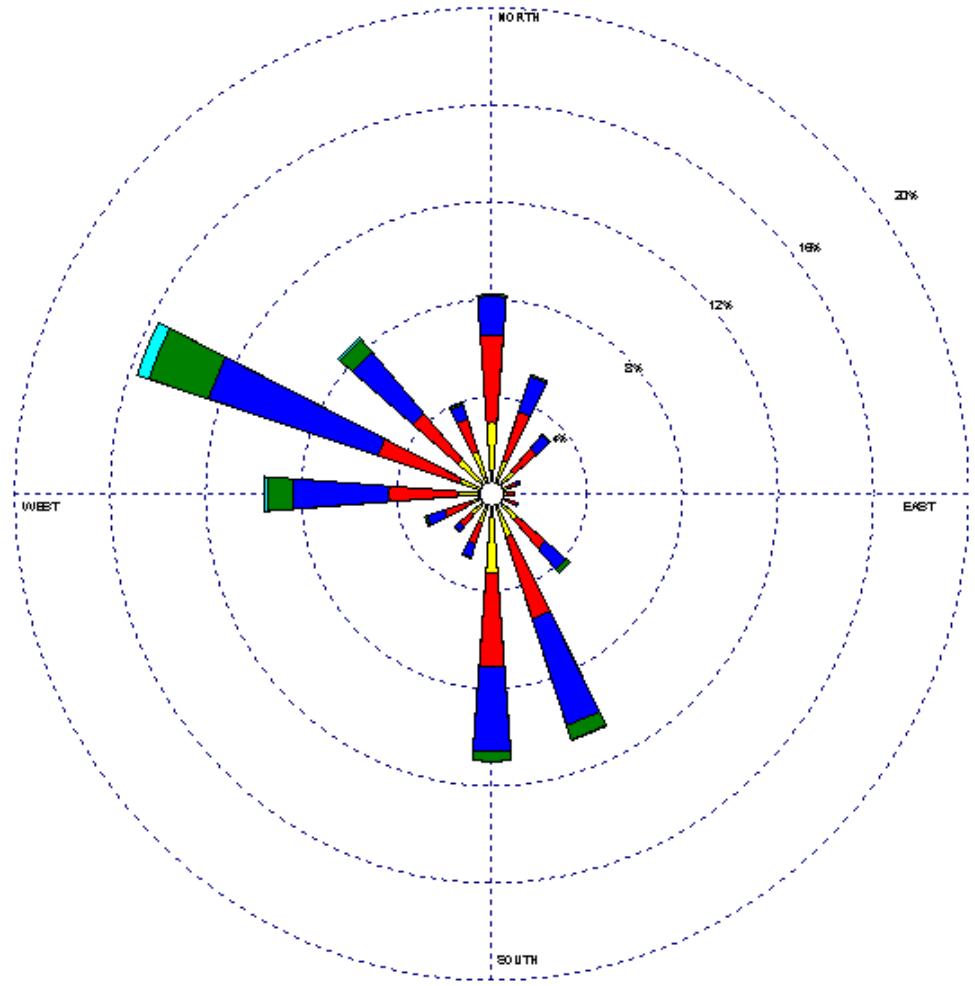
WIND ROSE PLOT
 Station #14735 - ALBANY/COUNTY ARPT, NY

Wind Speed (m/s) 	MODELER 	DATE 11/1/2002	COMPANY NAME
	DISPLAY Wind Speed	UNIT m/s	COMMENTS
	AVG. WIND SPEED 5.08 m/s	CALM WINDS 8.40%	
	ORIENTATION Direction (blowing from)	PLOT YEAR-DATE-TIME 1961 Apr 1 - Apr 30 Midnight - 11 PM	PROJECT/PLOT NO.

Rare wind from the east – mostly south and west, some from the north, strongest winds come from the west.

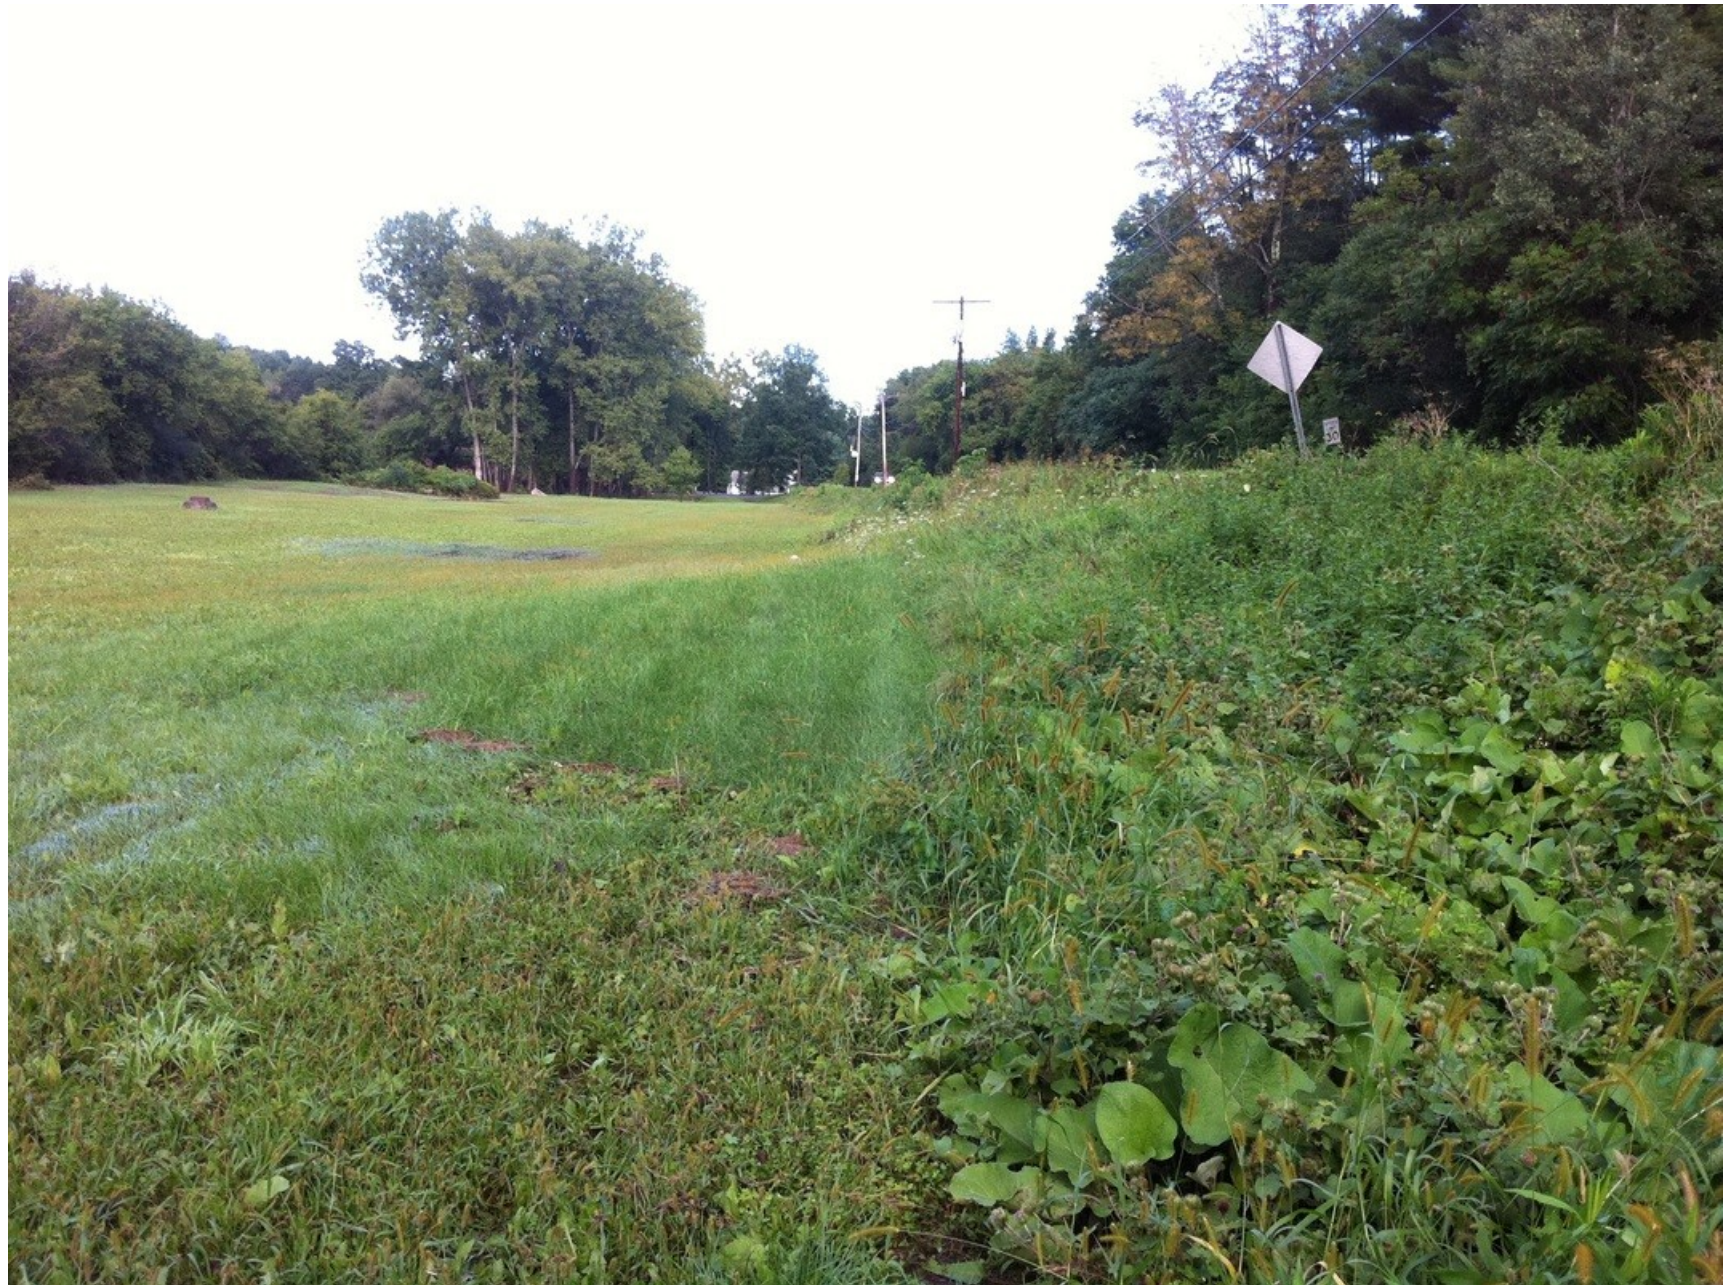
Wind -

Rare wind from the east – mostly south and west, some from the north, strongest winds come from the west.

Wind -

Rare wind from the east – mostly south and west, some from the north, strongest winds come from the west.

See wind rose

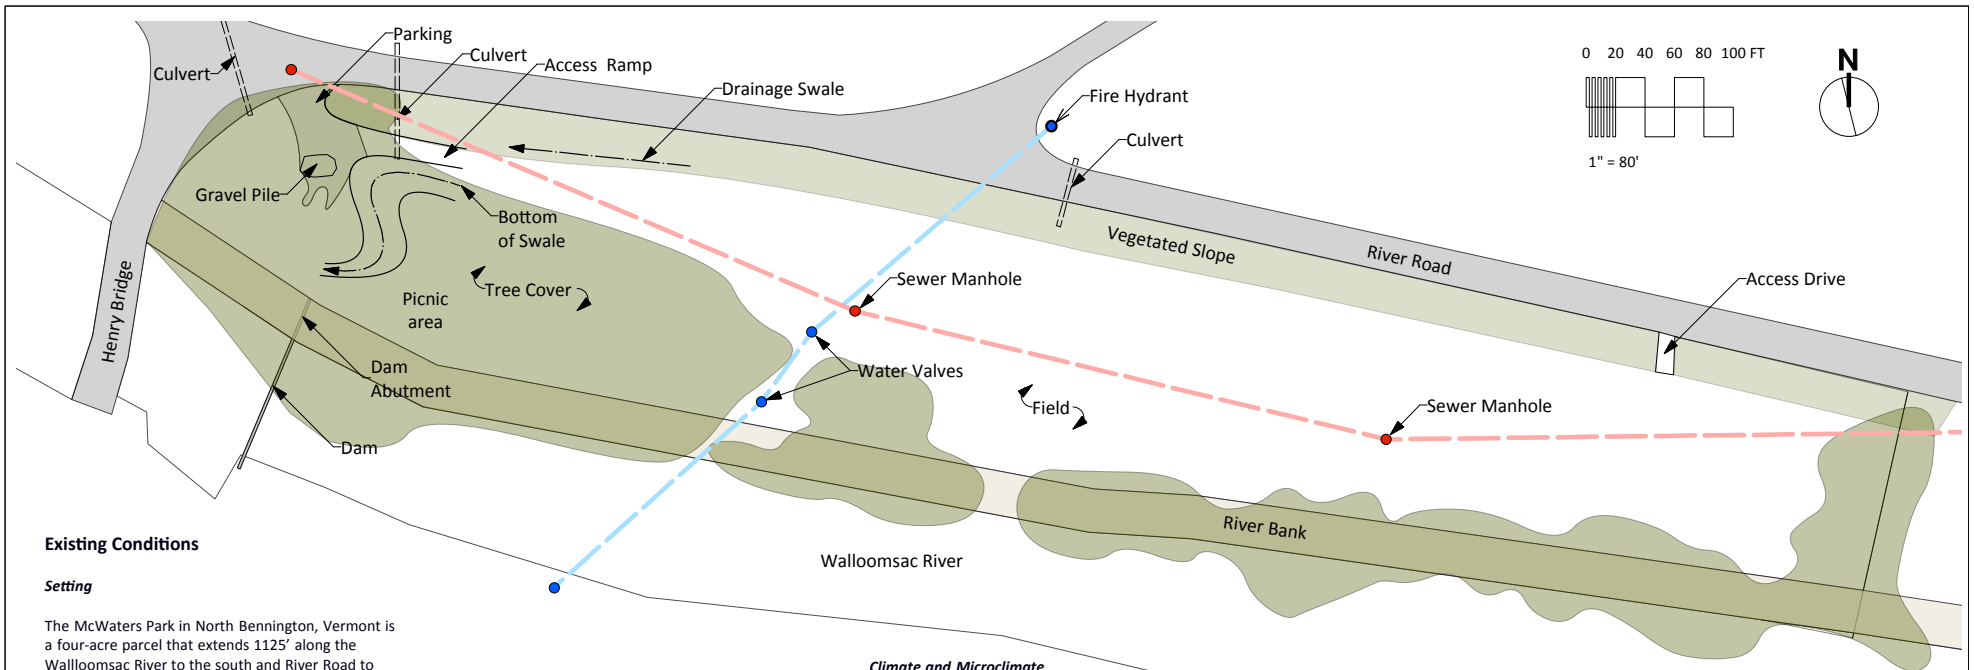
Existing Conditions | 1 of 2

Existing Sources – location, quality, dependability and sustainability:
The river

Watershed and flow patterns
Culverts with seasonal drainage from the hillside to the north

Potential for pollution -
Flow off the road with salt etc

Flooding and ponding
Culvert floods with spring rain on frozen ground
Flooding from river is rare

Water lines, septic, well location
See map

Erosion – existing and potential
Erosion has occurred off the road bank

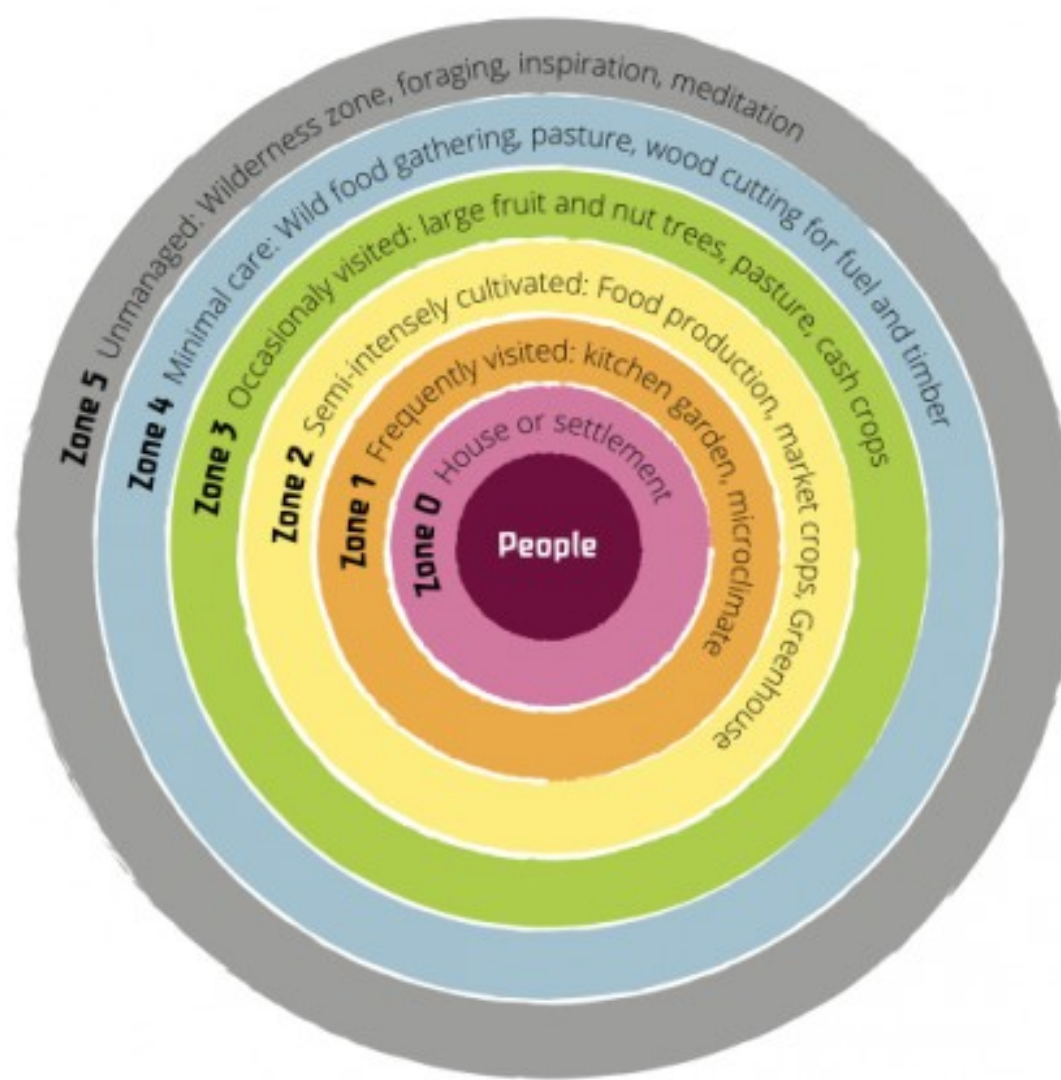
Accessibility and intimacy – Consider a map of zones that define distribution of personal time and attention (You can do things to manipulate your behavior like planting annual veg crops around a new tree.)

Zone 0 – home/work

Zone 1 – visited daily – on the path of daily activities –
intensive daily management possible

Zone 2 – visited frequently – easy to go there – weekly
management

Zone 3 – visited occasionally – have to plan time to be there
– monthly management

Zone 4 – rarely visited – considerable effort– things
requiring only seasonal to yearly attention

Zone 5 – wild and un-managed

McWaters Park is in our zone 3-4
